Basin Closure and Liner Installation

GEORGIA POWER PLANT YATES

Newnan, Georgia

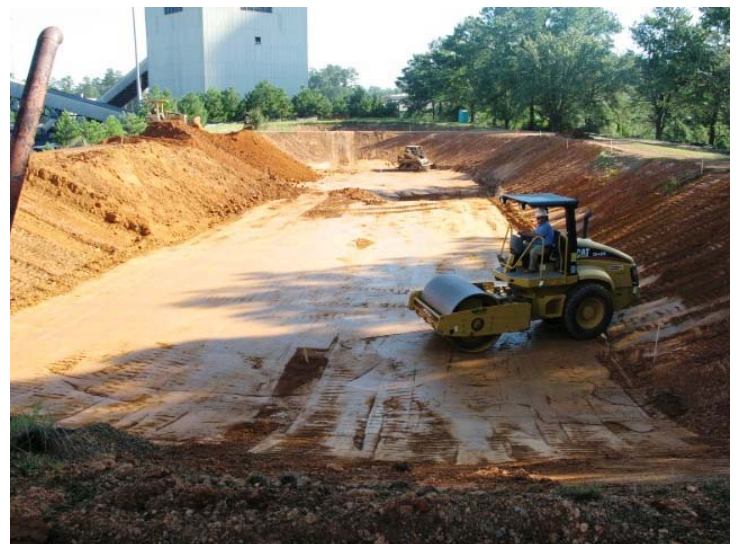
Following the removal of all impacted material, any unsuitable sub-grade soils consisting of high organic or sandy material were removed as sub-grade preparation for the liner. Sub-grade preparation consisted of rough grading to the desired elevations, slopes and contours. Low areas were brought to the specified elevations in compacted lifts, with the final surface elevations being proof rolled with a smooth drum compactor. initiation of liner installation activities.

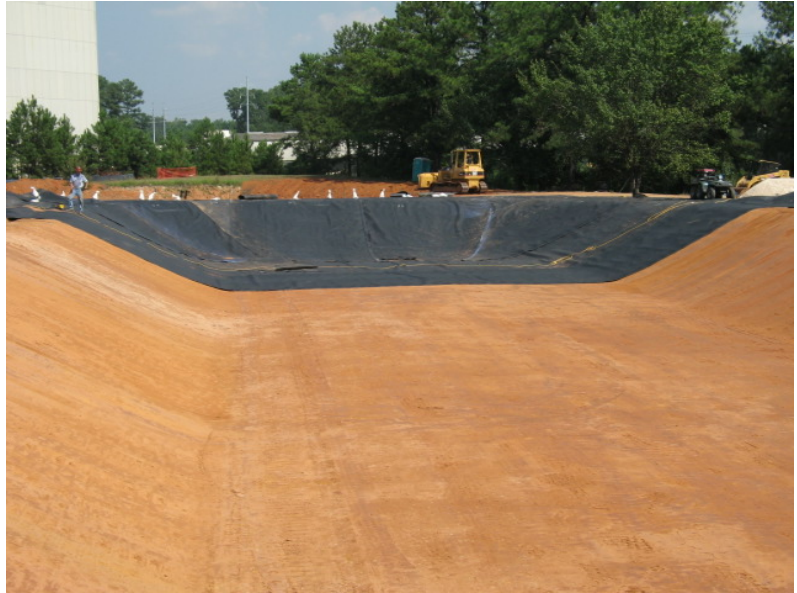
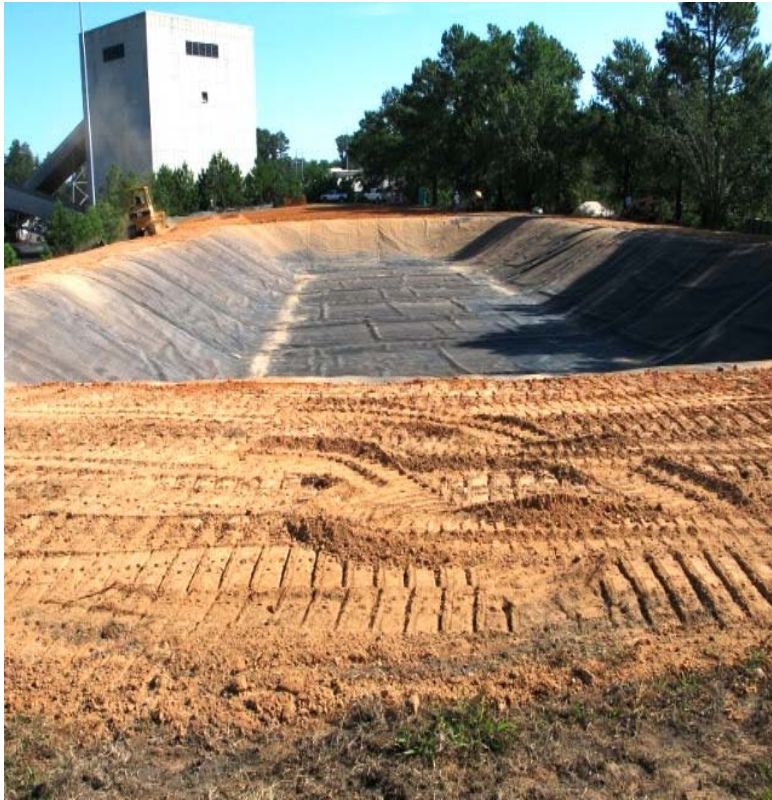
An anchor trench was excavated along the top perimeter of the basin prior and final compaction tests were performed on the basin floor to ensure the sub-grade was suitable for liner installation. A “Z” spreader bar was attached to an excavator to facilitate liner deployment. The HDPE liner panels were installed vertically down the slope and across the pond floor overlapping the adjacent panel between 4 to 6 inches. After each deployment of 2 to 3 liner panels, a technician performed a trial test weld utilizing a fusion welder prior to field seaming each morning and afternoon. All pipe boot penetrations were performed utilizing an extrusion welder. All fusion weld seams were “air tested” and all extrusion weld seams were “vacuum box tested” as part of the project QA/QC program.
